All Show and All Substance in Tilburg, NL

Efficient Relining with **HOBAS®** NC Line® Wins No Dig Award

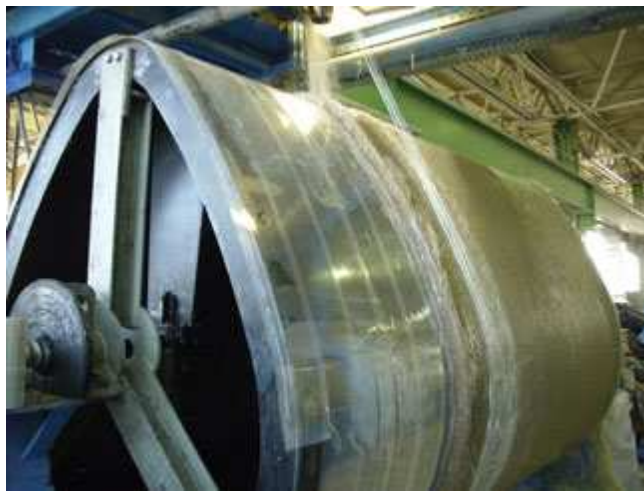
The application of (cured-in-place) hose relining could not be implemented for several reasons, mainly concerning the uneven distribution on the non-circular sewer walls which would anticipate uneven load distribution as well as possible buckling because of the required wall thickness, deviations, angles, and for simply being irreversible once applied. Apart from this, there was little experience with hose relining in large non-circular constructions as such and the method does not allow temporary use of the sewer while being applied. HOBAS NC Line therefore promised to be the better solution. During its installation the sewage is redirected. At heavy rainfall, however, the HOBAS NC Line can be used temporarily and may be evacuated within 10 minutes.
